The Absolute Beginners Guide to the Range Rover P38 Electronic Air Suspension

INTRODUCTION

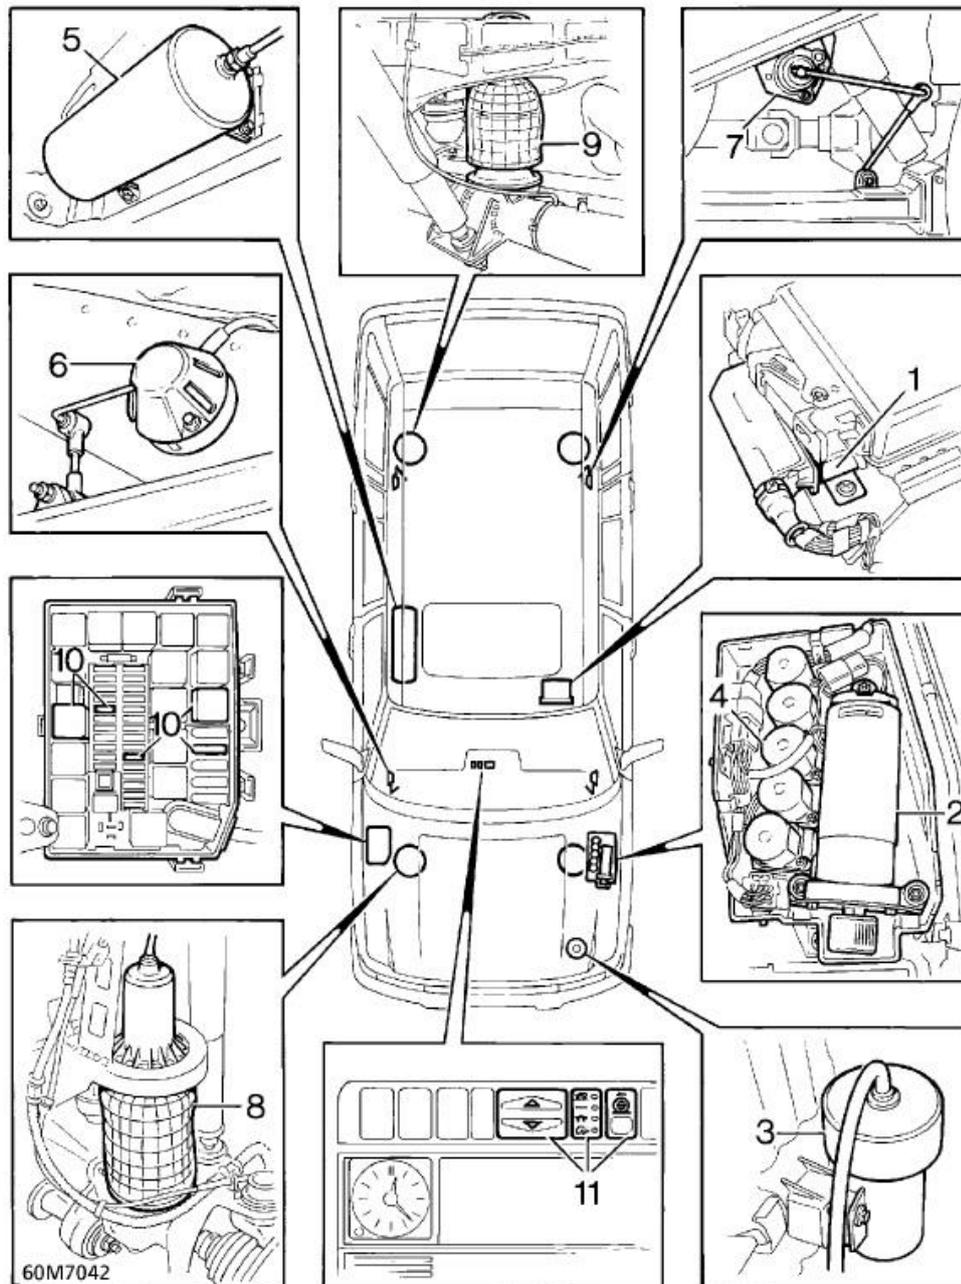
Component Locations

1. ECU Control Unit (under Front Left Seat)
2. Air Compressor
3. Air Dryer (fixed to engine air filter box)
4. Valve Block with Valve Actuators
5. Air Reservoir (under Right Side Chassis level with Right Front Door)
6. Front Height Sensor (with protective cover – heat shield not shown)
7. Rear Height Sensor (note longer activator Arms)
8. Front Air Spring
9. Rear Air Spring
10. Engine Bay Fuse Box
11. Height selector switch (left) and Manual Switch (Right)

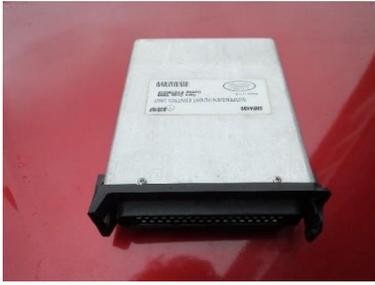
ELECTRONIC CONTROL UNIT (ECU)

The ECU, located under the left front seat, sends and receives information and commands to the suspension system through a large [35-pin connector](#). This also contains the data wire to retrieve/delete fault messages, program various elements, and view real time data using diagnostic equipment (Test Book for dealers, and third party equipment by others). The ECU is very reliable due to input and output overload protection. Whilst it is not 'waterproof', it is 'water resistant'.

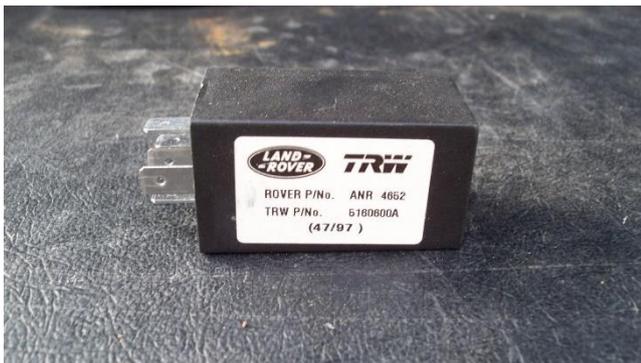
A Relay is an electrical mechanical switch. A small amount of electrical power operates an internal switch to enable a much higher power circuit. E.g. a low power circuit from the ignition key/switch, via one or more relays can switch a much larger power circuit such as the starter motor. This is an image of the special suspension system Relay and Timer unit located under left plastic base panel of left front seat.

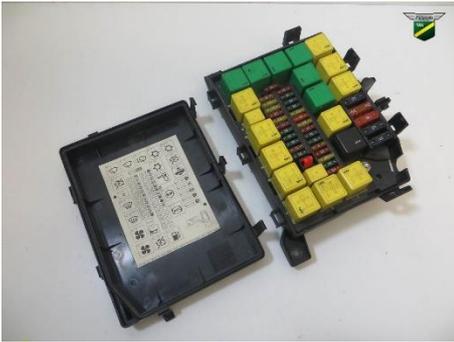
FUSE BOX

The suspension system uses three fuses and one relay located in the engine compartment fuse box. Fuse #24 (5A) for Key On, Delay Timer. Fuse #29 (10A) Powers ECU (also via Delay Relay Timer and Valve Driver Pack; Fuse #35 (10A) Ride Height and Inhibit switches; #40 (40A), for Air Compressor, Diaphragm Valve via a four-pin (yellow) relay #20. These are located in the Engine Bay Fuse Box. With the P38, whenever things stop working for no apparent reason (a common situation), this is the first place to check.

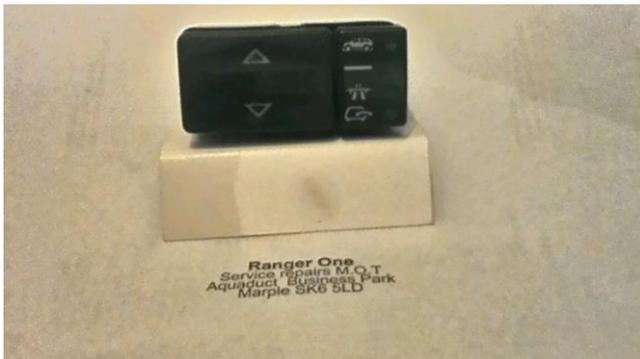
CONTROL SWITCHES

The height control rocker switch is located in the upper centre console and is used to show current system status and make manual height changes. The switch contains indicator lamps to identify current or selected ride height. The lamp will flash on selecting a change until the new height is achieved. All lights flashing indicates a soft (non-critical) fault, after 3 minutes they will remain on and steady. A hard (more serious) fault is additionally indicated by a “SLOW MAX SPEED 30 MPH” on the

Next to the height selector switch is the inhibit/manual switch. This prevents the vehicle from automatically changing height between standard and low settings. As this stops something from happening automatically, quite a few owners think it is broken as when pressed, nothing changes. If the lamp comes on – it is working. Often used when towing a caravan or trailer. It is also referred to as the ‘manual’ switch, as when it is engaged (lamp on), any height can be manually selected.

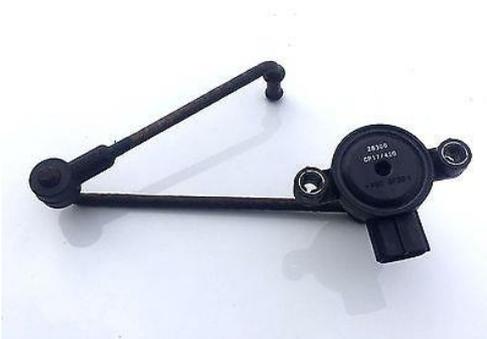
HEIGHT SENSORS

The height sensors are chassis/Axle mounted units that are connected via hinged link rods. There are four of them, one for each wheel. They are interchangeable from left to right, but not front to rear. Each sensor send information to report through a [connection block](#) the current height level to the [ECU](#). This information is converted by the ECU to a digital format in a range between 0 and 255 ‘bits’. Whilst this is not directly related to any measured height individually by wheel or as a system, for a very rough guide 1 ‘bit’ equals 1.5mm. Front

height sensors have an additional protective cover, and a heat shield as they are located adjacent and close to the exhaust system. These components are (other than leaks) the most likely culprits for EAS faults. They are constantly operating, and prone to damage given their location.

Over time, the internal parts of the sensor are liable to wear. This can result in unusual signals being sent to the ECU, causing sensor related soft faults. Diagnostic may show 'Signal Incorrect'.

If the fault then transfers left to right, then the sensor is broke. It is not repairable. If the fault remains on the original side, then the problem is in the cable or ECU (extremely rare).

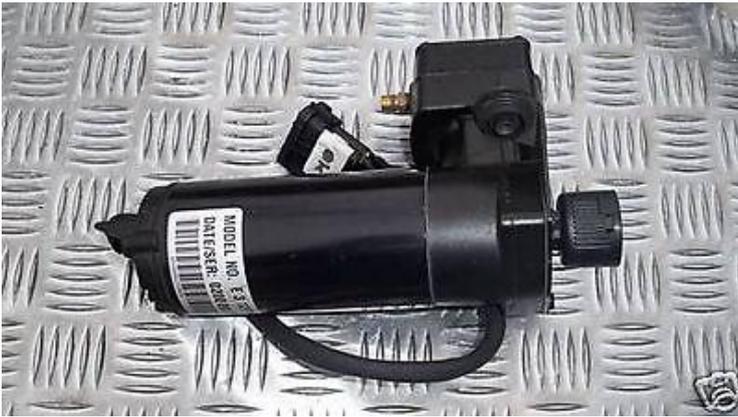
AIR COMPRESSOR

The electric air compressor does what it says on the tin – it takes air and compresses it. The unit has an internal thermal switch which protects the motor from overheating by telling the ECU to stop its power if its temperature exceeds 120°C. The ECU can also stop the compressor when the system pressure is above approx. 145 psi, or in the event of various faults. The compressor, valve block, valve driver, and air dryer are located in the

engine bay above left wheel area. An air inlet filter is located on the front end of the compressor unit. The compressor is powered directly from a fuse box relay via a [connector](#) point. They can fail or become less efficient over time. Only very wealthy owners replace them. Everyone else just services or repairs them.

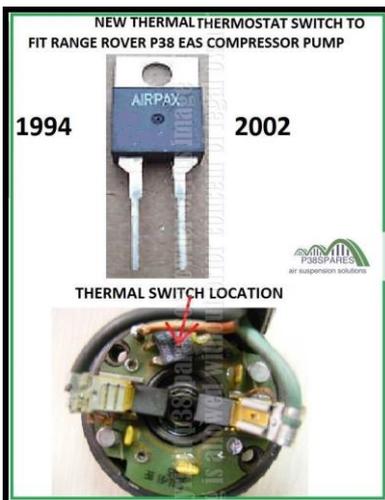
THERMAL SWITCH

The thermal switch is located within the [compressor](#) motor housing, on the circuit board attached to the motor end cap. If the internal temperature exceeds 120°C it opens, breaks the circuit to the ECU. This then stops the motor in the compressor. When it cools to below 90°C it closes, and the compressor power is restored.

Remove compressor plug from socket. Test continuity between Orange wire and Black wire. If continuity, switch is ok. If none switch is faulty. OR if you (ridiculous thought for a P38 owner) don't own a test meter. Leave plug connected and strip a small amount of insulation on Orange wire. Connect a wire to this and run it to ground. If compressor then runs, thermal switch has failed. Replacement is AIRPAX 67L 120.

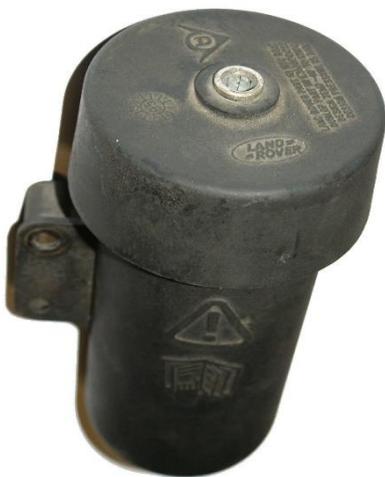
AIR DRYER

The air dryer is fixed to the engine air filter case at the left front of the engine bay. Vertically fitted cylinder thus taking advantage of gravity to drain moisture during the exhaust process. It is connected to the valve block by two 8mm Diameter air pipes. Compressed air passes through the valve block, into the bottom of the Dryer. The Dryer case contains moisture absorbing material so returns 'dry' air out of the top and back to the valve block and onwards to the storage cylinder. A [diaphragm valve](#) inside the valve block directs exhausting air through the dryer in the opposite direction, removing accumulated moisture from the dryer and thereby 'regenerating the absorbent material. Simple but clever.

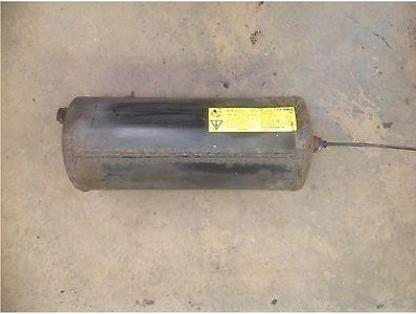
RESERVOIR

A compressed air storage tank is mounted to the chassis on the right side and approximately beneath the front right door. A single nylon airline serves as both inlet and outlet. It has a drain facility to remove any condensed water that may gather over time.

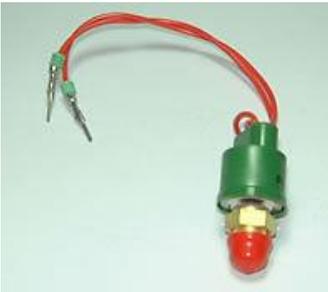
PRESSURE SWITCH

The pressure switch is located on the underside and front of the metal [valve block](#) (it is a small green cylinder with two red wires leading to the Driver Pack Unit). The pressure switch contacts should be open at pressures below 120 psi. The pressure switch contacts should be closed at a pressure of 150. Psi. This switch tells the system when to start or stop the compressor.

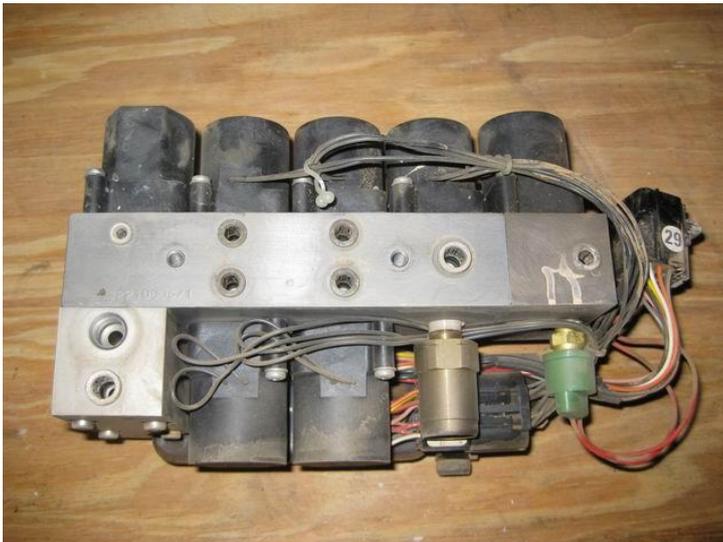
VALVE BLOCK

The valve block controls the flow of air in the system, in response to decisions made by the ECU. This is done through the use of external valves, and internal non-return valves, all are fitted on or within the metal valve block. Seven valves are used, one for each corner (wheel), and one each for inlet and exhaust. One diaphragm valve is used to control the direction of airflow in the dryer and is energized by the compressor relay. An air release valve (small brass cylinder fitted on the underside of the metal valve block, behind the pressure sensor) this will immediately release all air in the valve

block if pressure exceeds 180 psi. (You will know when it operates as it makes a spectacularly loud noise, then it must be replaced)

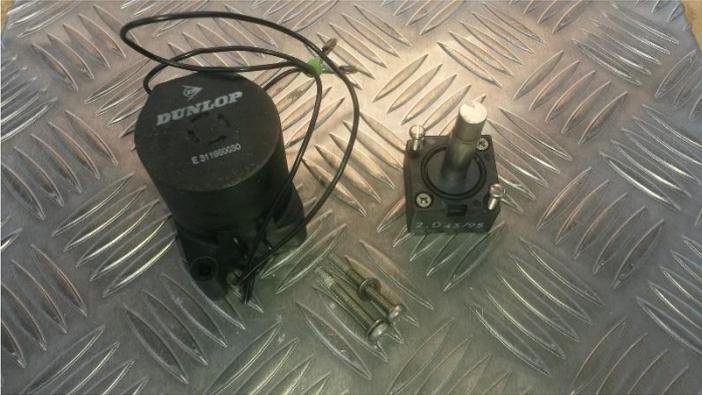
VALVES

The valves are essentially in two parts. There is an outer case that contains an electromagnet, connected to the [Driver Pack](#) by two black wires. Inside this is the actual valve unit, which is a spring-loaded metal 'plunger' that covers or uncovers holes in the metal valve block. Silicon rubber 'O-rings' of various sizes are used to ensure an air tight seal. A variable and pulsing electric current generates a magnetic field, and this raises the internal plunger against a spring, thus

opening the air holes in the block. They rarely fail, but when they do it is usually as a result of the [Driver Pack](#) having a severe mental breakdown which in turn damages the actuator head.

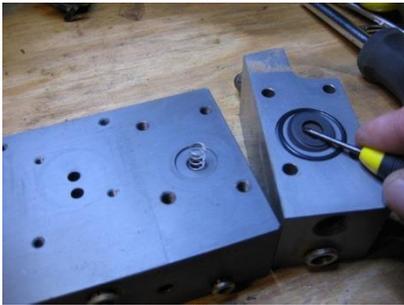
DIAPHRAGM VALVE DISC

Because air entering and leaving the system share many of the same routes (but not at the same time), this must be controlled. The Diaphragm Valve and its disc does this. The disc sits inside the valve block, held down with a small spring. It is a common reason for system failures, but simple to replace. This disc separates and directs air coming in from the compressor and air leaving through the exhaust. Its failure may often cause compressor air to get immediately dumped out through the exhaust bypassing the entire system – not ideal.

Remove exhaust silencer, and with system running place finger over exhaust port. You should not feel any air against your finger. If there is, it indicates a problem with the diaphragm valve or solenoid. Replace Diaphragm valve disc.

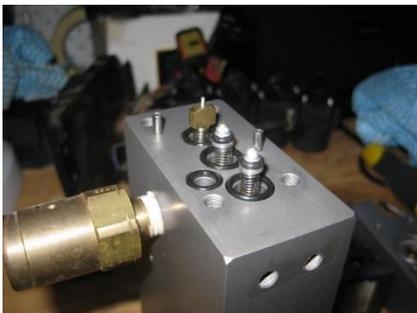
NON-RETURN VALVES

These internal valves in the valve block stop air flowing backwards, hence their name of Non-Return Valves. Note which way up they go, and the rubber [O rings](#) (seals). Also note the brass cylinder in the image. That is the emergency air pressure relief valve.

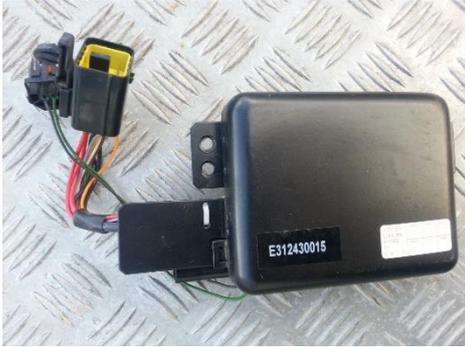
VALVE DRIVER PACK

The Valve Driver Pack is a slim black rectangular case bolted to the metal [valve block](#). This contains the electronics to operate the valves as the ECU commands via its [connector](#). It is a sealed unit. In simple terms, it either works or it does not. I know of no successful repairs to this component. It must be noted that a major failure of this driver pack, may also damage one or more of the actual [valve units](#). It is not uncommon to replace the driver pack unit and continue to have valve issues.

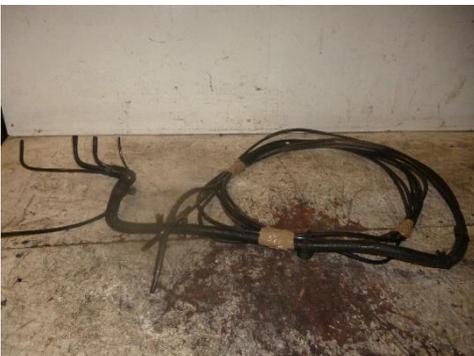
NYLON AIR HARNESS

All components are connected by nylon air lines to maximize corrosion resistance and temperature related fatigue failures. 6mm air pipes go to each air spring, and to/from the air tank plus the short blue pipe from compressor to metal air block. A 4mm vent line exits the diaphragm solenoid. Two 8mm Air lines connect the Air Dryer to the valve block. They are all repairable/replaceable.

Damaged air lines should be replaced as an entire length; that stated, it is perfectly acceptable to use standard 6mm line connectors, possibly with a short length of replacement airline after cutting the damaged section out. The airlines can be bent to shape by inserting some electrical cable to prevent 'creasing', bend to shape, place in hot water, followed by cold, and removing the electric cable. It is essential that where the repaired lines enter the valve block, they do so straight, and at 90 degrees to the block. It is best to slightly trim to a cone shape the ends with a pencil sharpener by 1mm. This makes it easier to push completely home past the two internal O rings within the block.

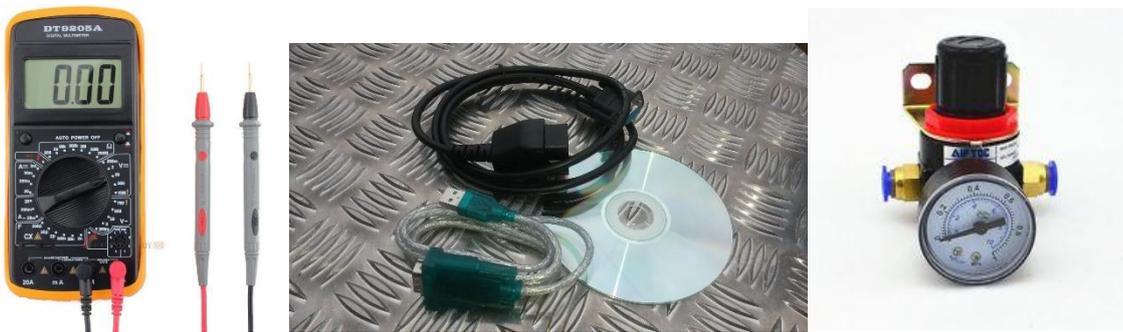
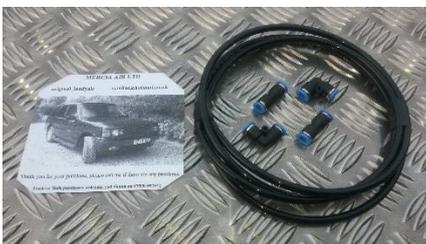
An electrical Multimeter; Air Suspension Diagnostic hardware/software; a Pressure Gauge. A spray bottle containing a 50:50 washing liquid and water mix for spraying over airline components and watching for bubbles indicating leaks; and a length of 6mm air line with auto push fit/release connectors.

Diagnostic equipment such as EASunlock, Nanocom, Hawkeye etc. are essential. For most diagnostic tests and indeed maintenance/repair, the [Air Springs](#) and [Air Storage Tank](#) must be safely depressurised. All the standard diagnostic tools can achieve this. However, diagnostics results and fault codes must be treated with caution. **The diagnostic signal cable stops at the ECU, and does not monitor any engine bay located items. The ECU can only 'guess' what a fault is, depending on what it notes is happening.**

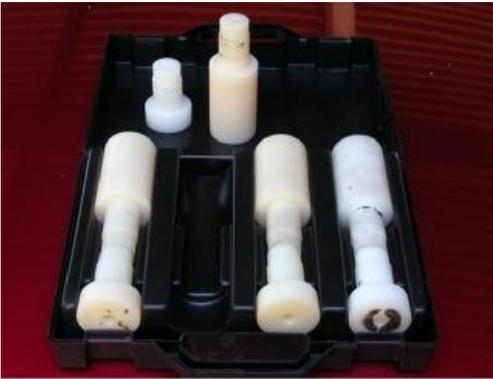
Above - Genuine Land Rover LRT 60-003 height calibration blocks. Cost c. 180 UK pounds.

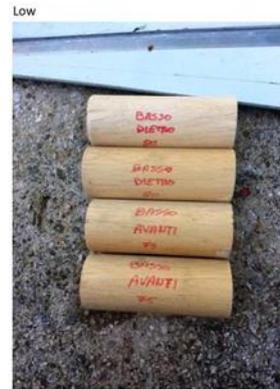
Below – Home Made calibration blocks. Cost c. 2 UK Pounds.

First, we need to obtain the calibration blocks (4 for each height) for the different height settings. I used a very simple method of making my own blocks. From a DIY store I bought a 2m length of round hard wood with a 30mm diameter and I cut 16 lengths from this.

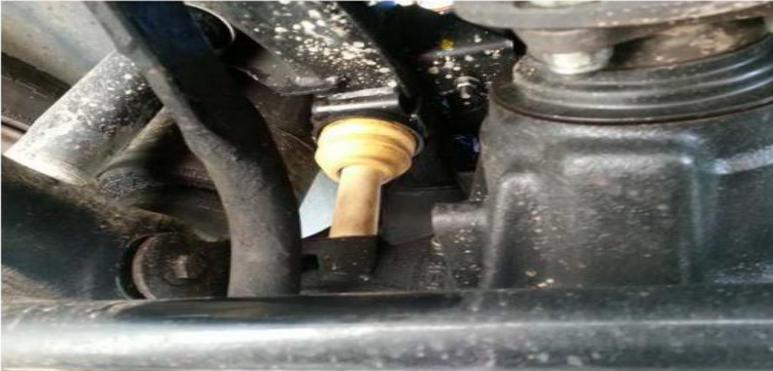
Foto 4

See photo 4 (front) 5 (rear)

Once the calibration blocks have been positioned under the chassis on the axles, slowly lower the vehicle onto the blocks. CHECK THAT THE CALIBRATION BLOCKS ARE FIRMLY SECURED UNDER THE WEIGHT OF THE VEHICLE. CHECK BY USING A TOOL TO SEE IF THEY MOVE. **DO NOT PUT YOUR HAND UNDERNEATH THE BUMP STOP**

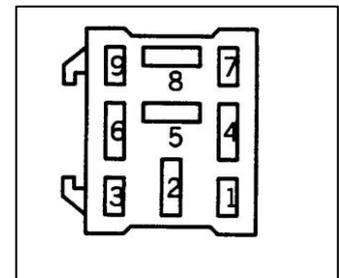
C139 Valve Block to Valve Driver Connector

No.	Colour	Description
14	White	Rear Left Valve Hit and Drop Control
15	Red/White	Rear Left Valve 12 Volt
16	-	-
17	Red/Orange	Exhaust Valve 12 Volt
18	Orange	Exhaust Valve Hit and Drop Control
19	Red/Brown	Front Left Valve 12 Volt
20	Red/Black	Inlet Valve 12 Volt
21	Pink	Front Right Valve Hit and Drop Control
22	Yellow	Rear Right Valve Hit and Drop Control
23	Brown	Front Left Valve Hit and Drop Control
24	Slate	Inlet Valve Hit and Drop Control
25	Red/Pink	Front Right Valve 12 Volt
26	Red/L Green	Rear Right Valve 12 Volt

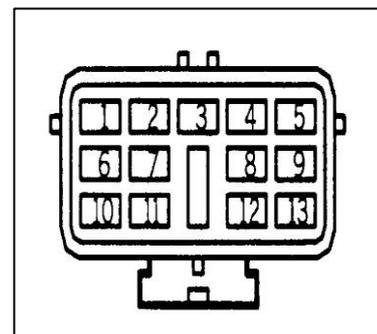
C142 Diaphragm Valve Connector

No.	Colour	Description
1.	Green	12V Power from Compressor Relay
2.	Black	Ground to C152, Pin 11
